Your Inspection Report

40 Halton Street
Toronto, ON M6J 1R3

RE: Report No. 4528
40 Halton Street
Toronto, ON
M6J 1R3

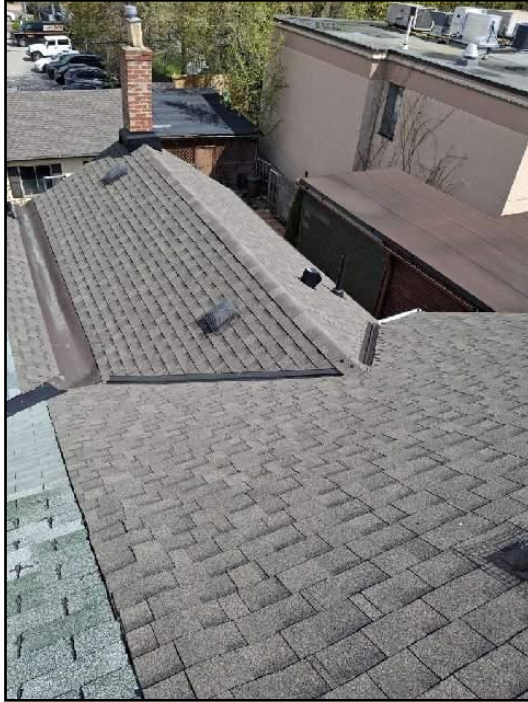
1.

- Composition shingles

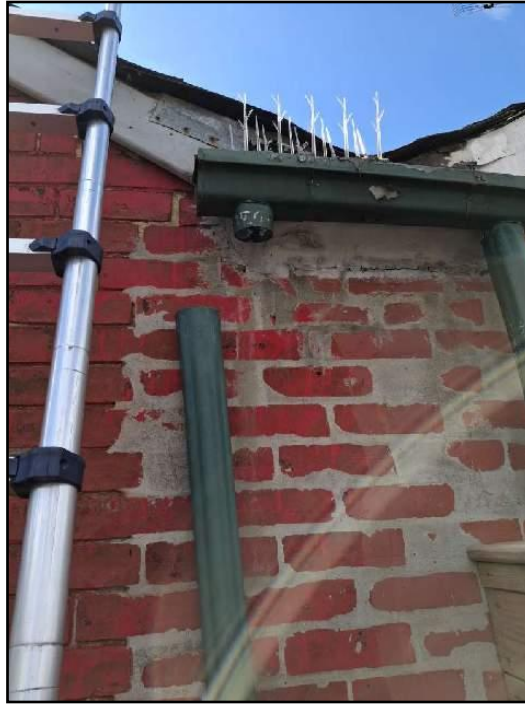
4. Condition: • Seal opening at wall.

Location: East Exterior

Task: Repair

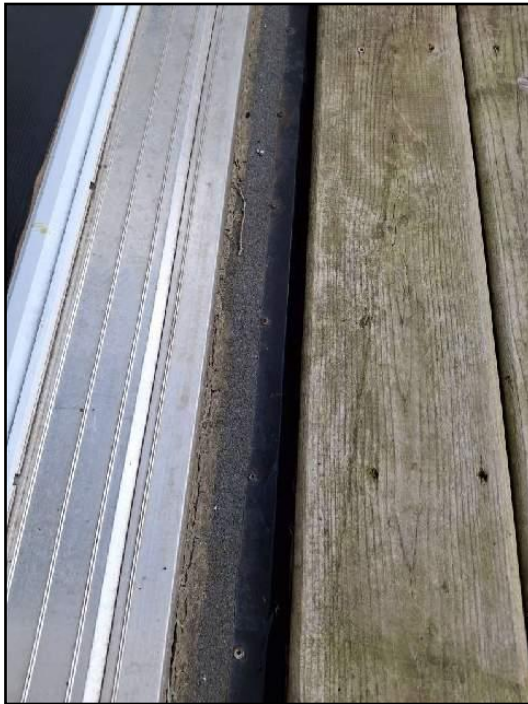
8. Missing flashing

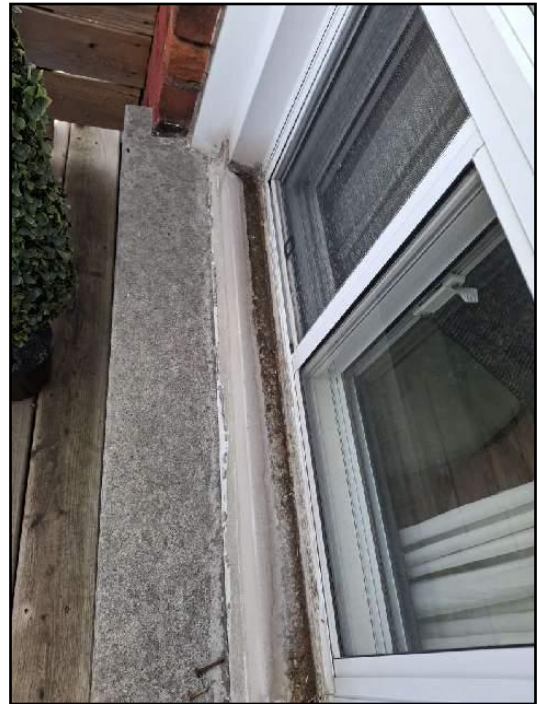
9. Poor slope

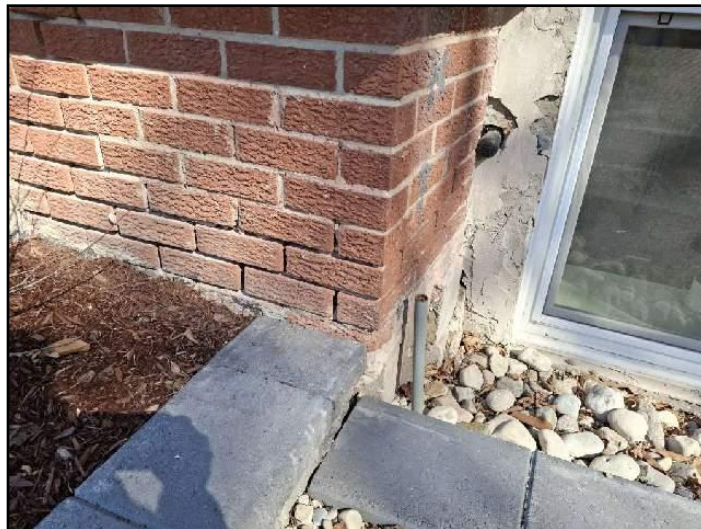
10.

7. Condition: • [Masonry deterioration](#)

Some tuckpointing and parging needed.

Implication(s): Weakened structure | Chance of structural movement

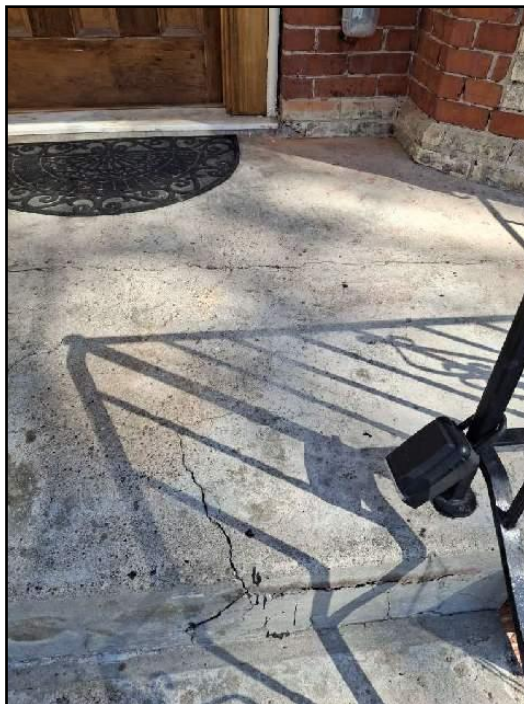
11.

8. Condition: • [Concrete cracked](#)

Implication(s): Chance of damage to structure | Material deterioration | Trip or fall hazard

Recommend sealing concrete with epoxy coating.

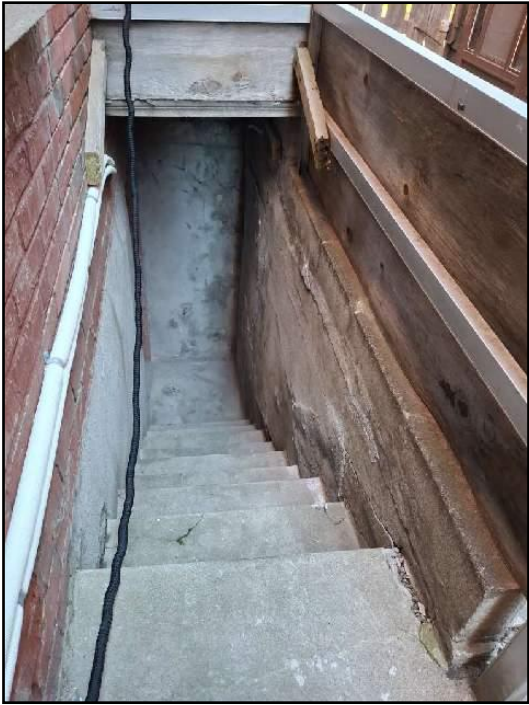
12.

9. Condition: • [Walls cracking, leaning, bowing or spalling](#)

Implication(s): Weakened structure | Chance of movement

Repair wall (replace parging) and add handrail.

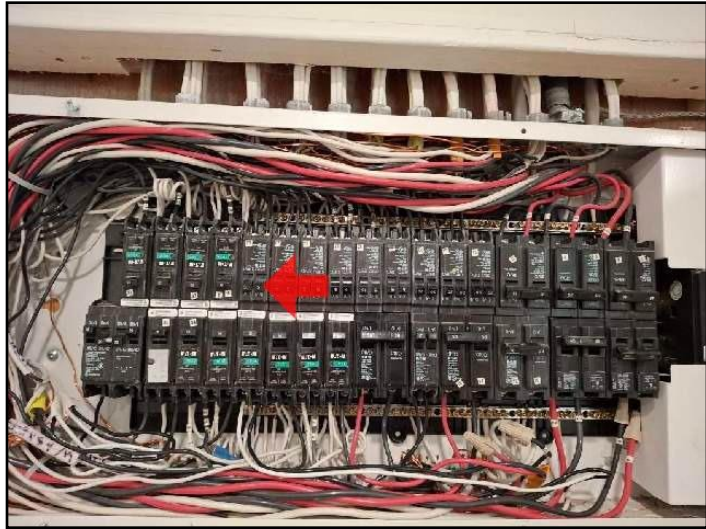
13. Condition: • [Double taps](#)

Add breaker to eliminate multi tap if nuisance tripping occurs.

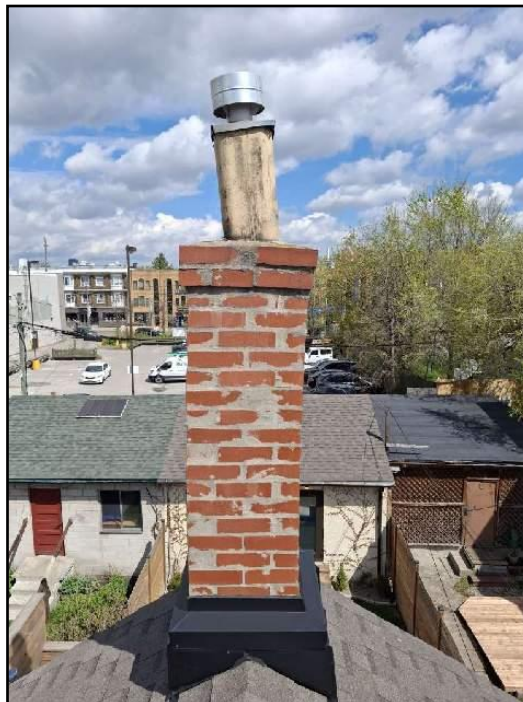
• [Abandoned](#)

14. *Not in use*

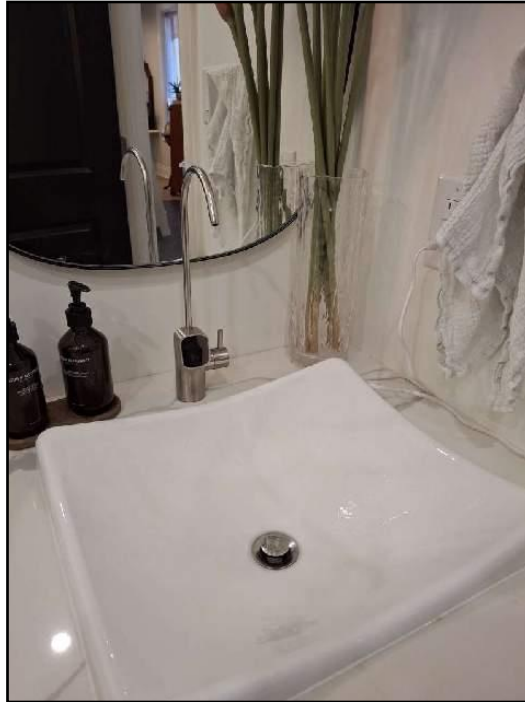
21.

20. Condition: • [Loose](#)

Implication(s): Equipment failure

Resecure loose faucet.

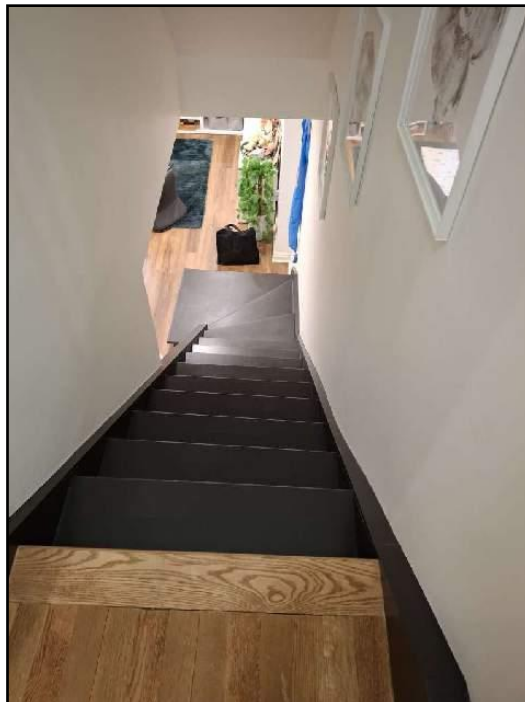
22. Condition: • [Missing](#)

Implication(s): Fall hazard

Add handrail to basement stairs.
