Your Inspection Report

40 Fuller Avenue
Toronto, ON M6R 2C3

Tuesday, June 9, 2026

RE: Report No. 4554
40 Fuller Avenue
Toronto, ON
M6R 2C3

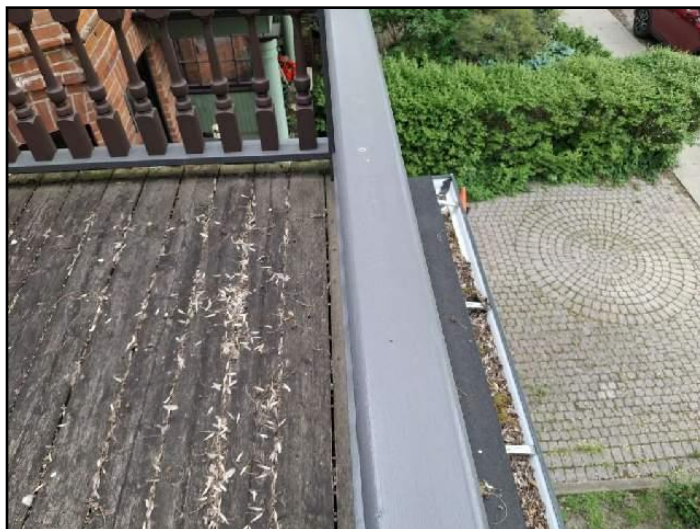
4.

Inspection limited/prevented by:

- Deck, could not inspect roof membrane below.

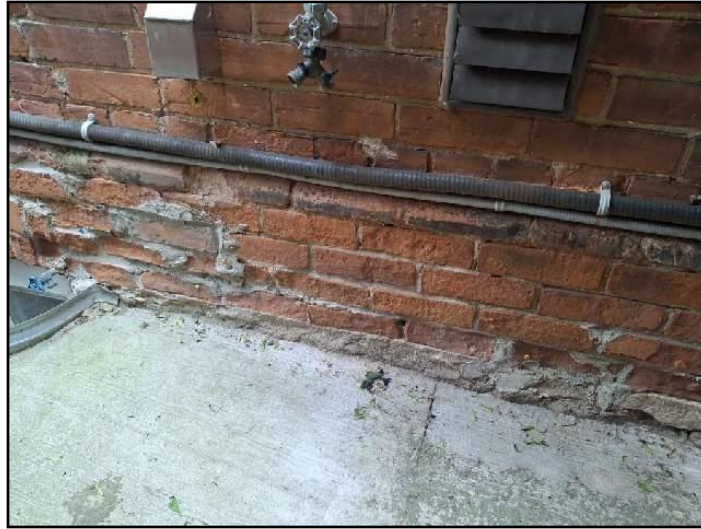
5.

- WALLS \ Masonry (brick, stone) and concrete**
- 3. Condition:** • [Masonry deterioration](#)
Typical tuckpointing and parging needed.
- Implication(s):** Weakened structure | Chance of structural movement
- Location:** Various Exterior
- Task:** Repair
- Time:** Regular maintenance
- Cost:** Minor

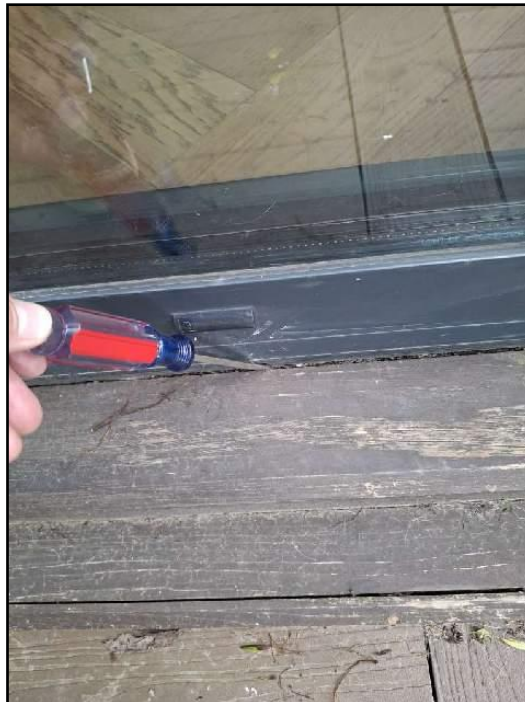
6.

4. **Condition:** • [Caulking missing, deteriorated or loose](#)

Seal trim at back door threshold.

Implication(s): Chance of damage to finishes and structure

Location: West Exterior

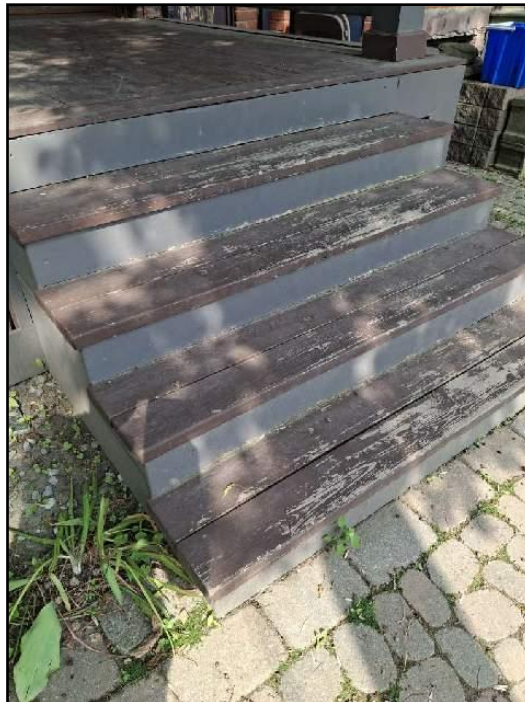
7.

5. Condition: • Loose deck board

Resecure first step at front porch.

Implication(s): Trip or fall hazard

Location: East Exterior

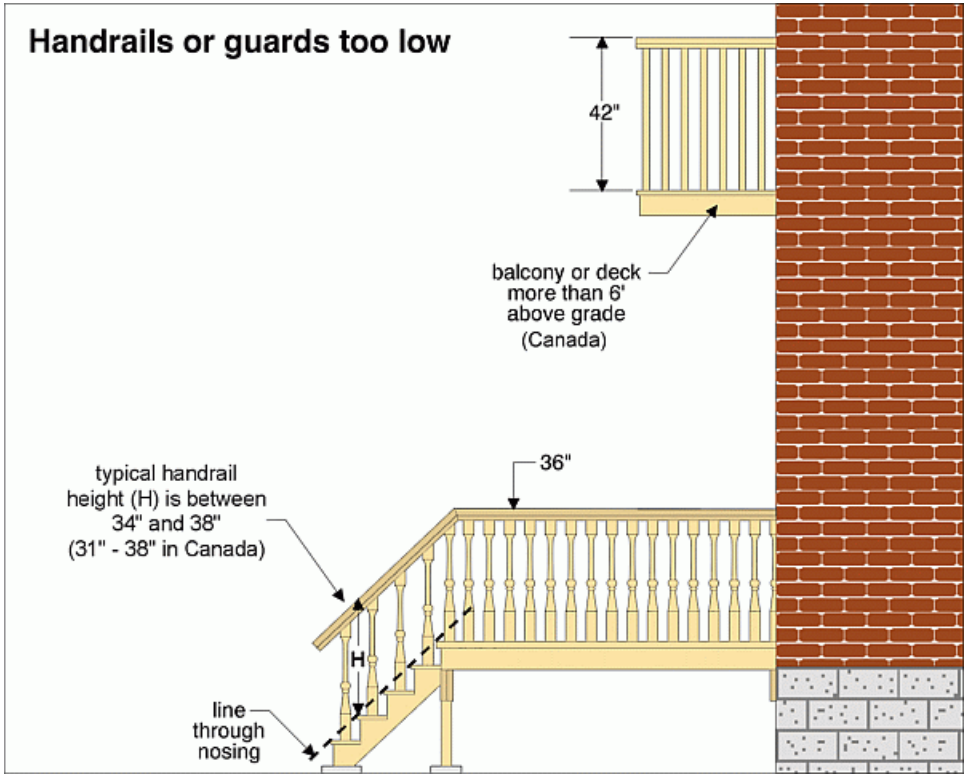
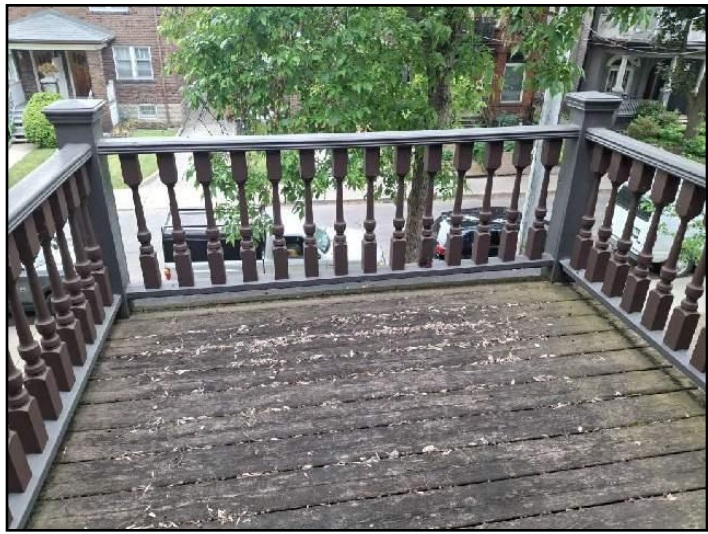
8.

6. Condition: • [Too low](#)

Implication(s): Fall hazard

Location: East Second Floor Balcony

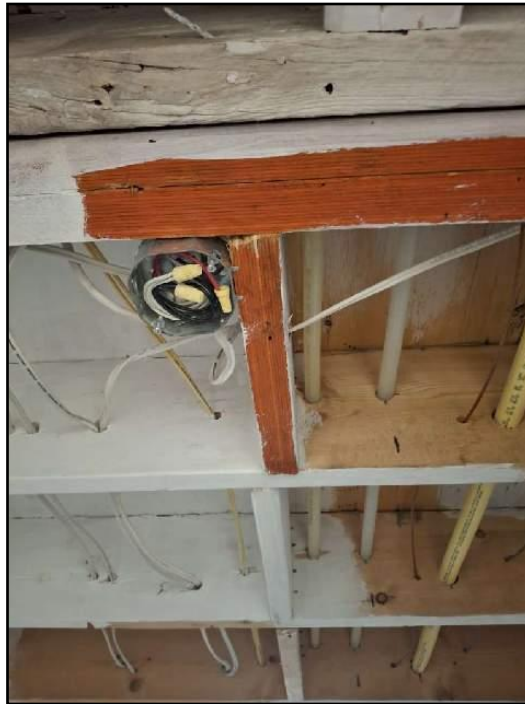
11.

9. Condition: • [Missing](#)
Implication(s): Electric shock
Location: West Basement
Task: Replace
Cost: Minor

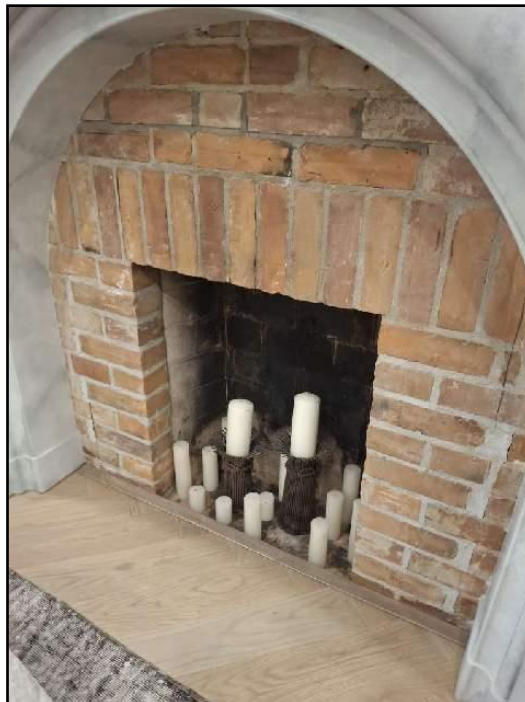
15. Do not use

11. Condition: • Not functional

Chimney and flue are available if conversion or restoration are desired.

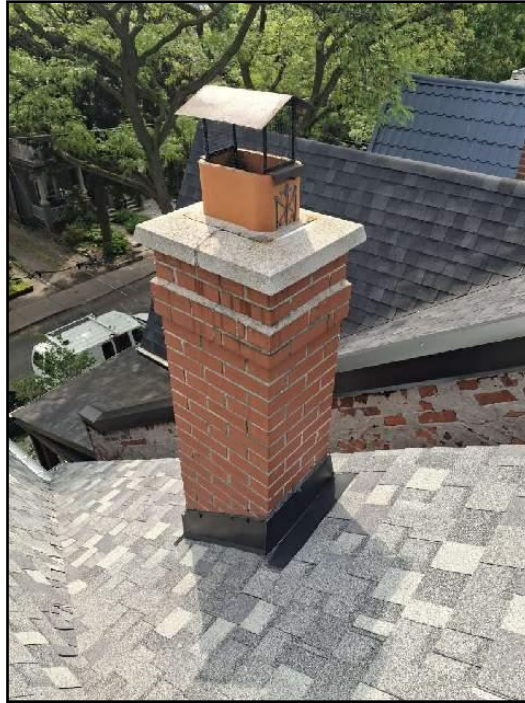
16. For fireplace only

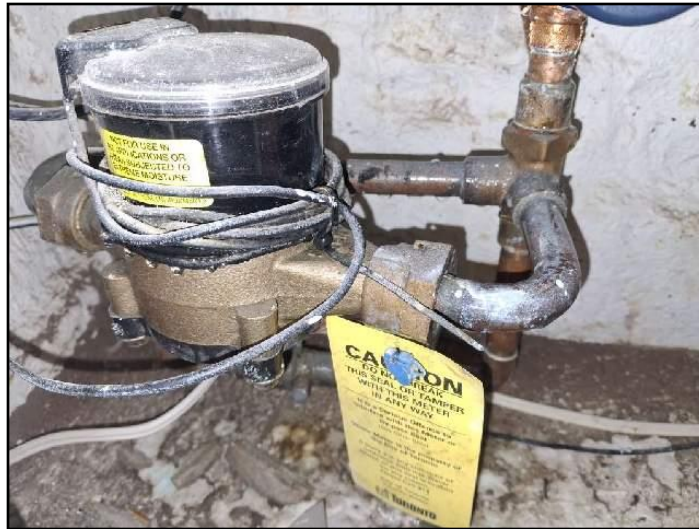
22.

15. Condition: • Excessive condensation at supply piping behind wall will result in water damage/rot. Recommend sprayfoaming east foundation wall and adding larger vented opening to shut off and meter.

Location: Northeast Basement

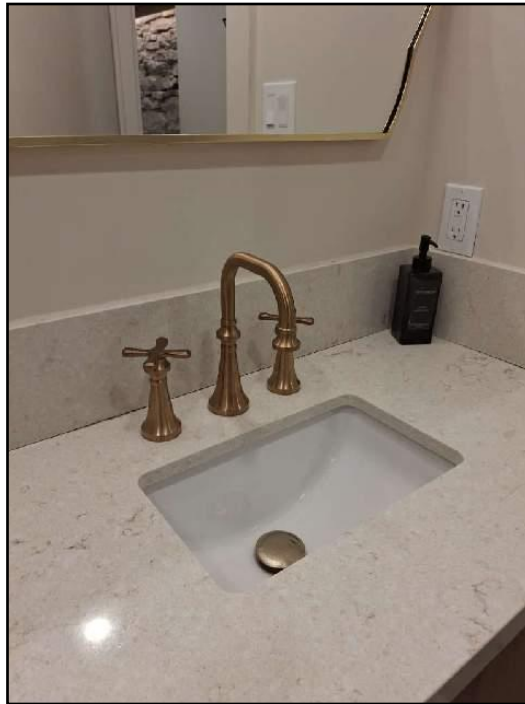
23.

17. **Condition:** • [Aerator obstructed](#)

Implication(s): Reduced water pressure and volume

Location: Basement Bathroom

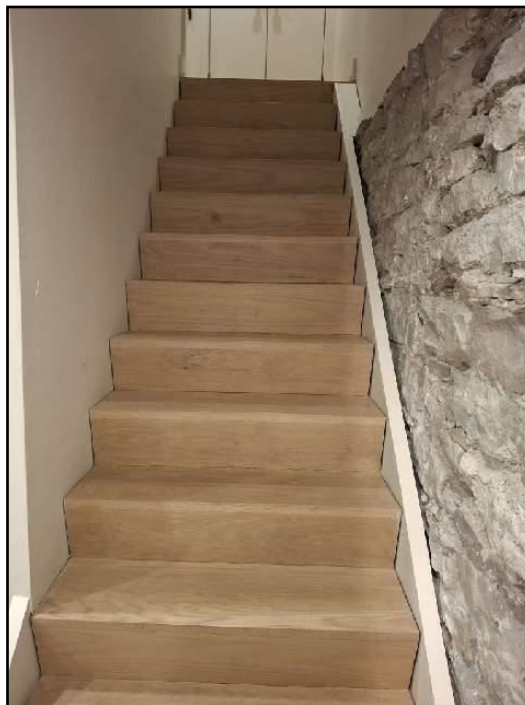
25.

19. Condition: • Missing handrail.

Location: Basement Staircase
