Your Inspection Report

20 Garden Avenue
Toronto, ON

Thursday, February 18, 2016

RE: Report No. 1716
20 Garden Avenue
Toronto, ON

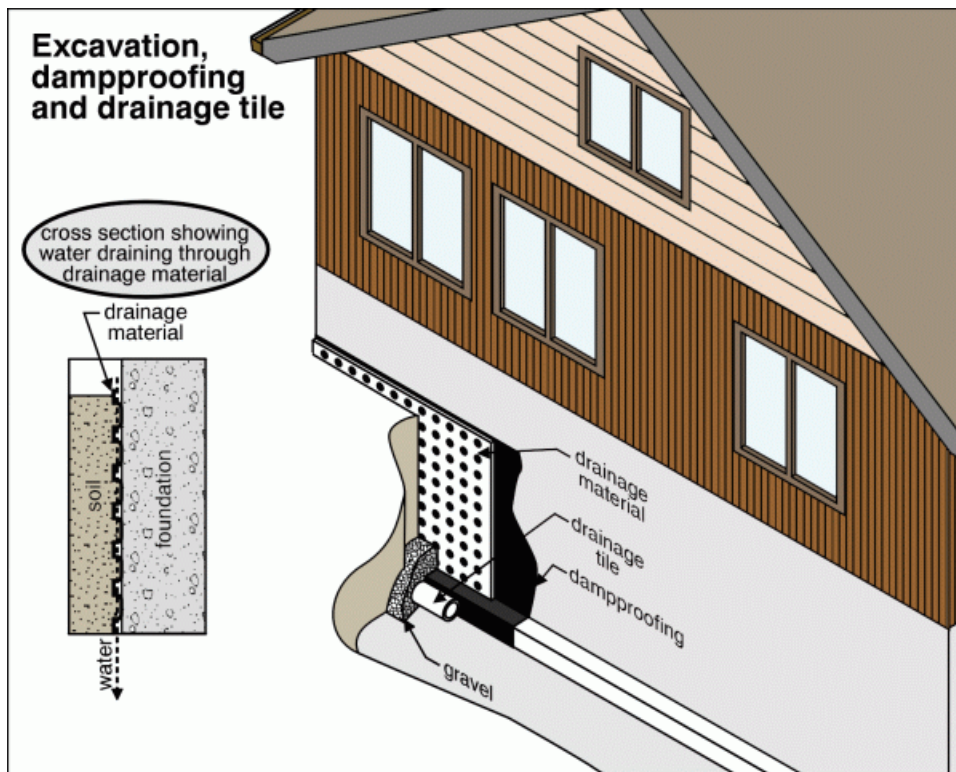
19. Condition: • [Excavation, dampproofing and drainage tile](#)

Implication(s): Chance of water damage to contents, finishes and/or structure

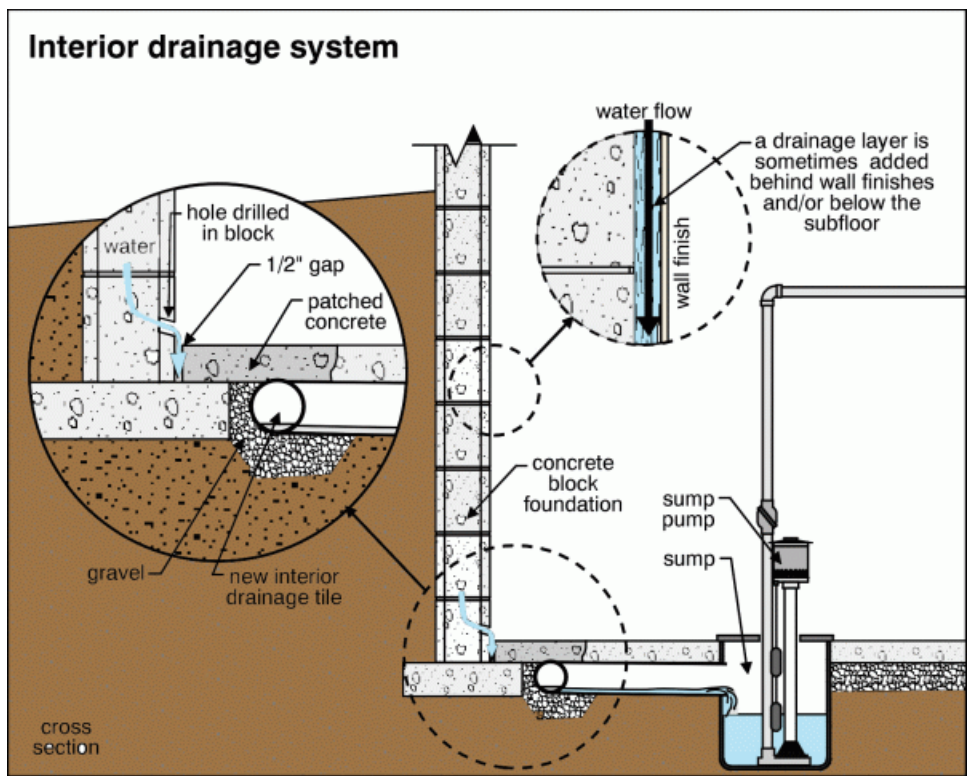
20. Condition: • [Interior drainage system](#)

Implication(s): Chance of water damage to contents, finishes and/or structure
