Your Inspection Report

15 Algonquin
Toronto, ON

Tuesday, April 5, 2016

RE: Report No. 1768
15 Algonquin
Toronto, ON

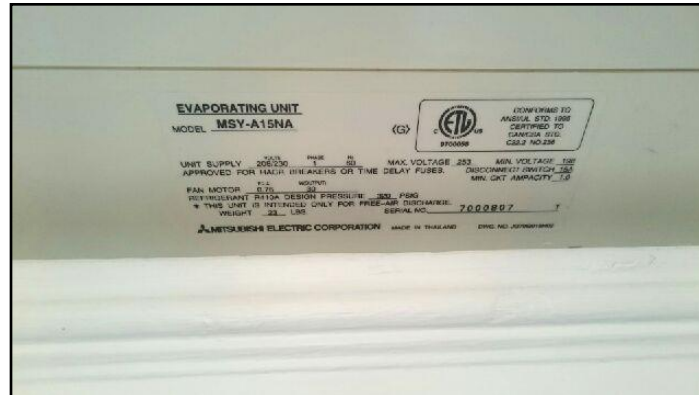
3. *Independent system*
