# Your Inspection Report

472 Lansdowne Avenue  
Toronto, ON

Tuesday, May 24, 2016

RE: Report No. 1839  
472 Lansdowne Avenue  
Toronto, ON

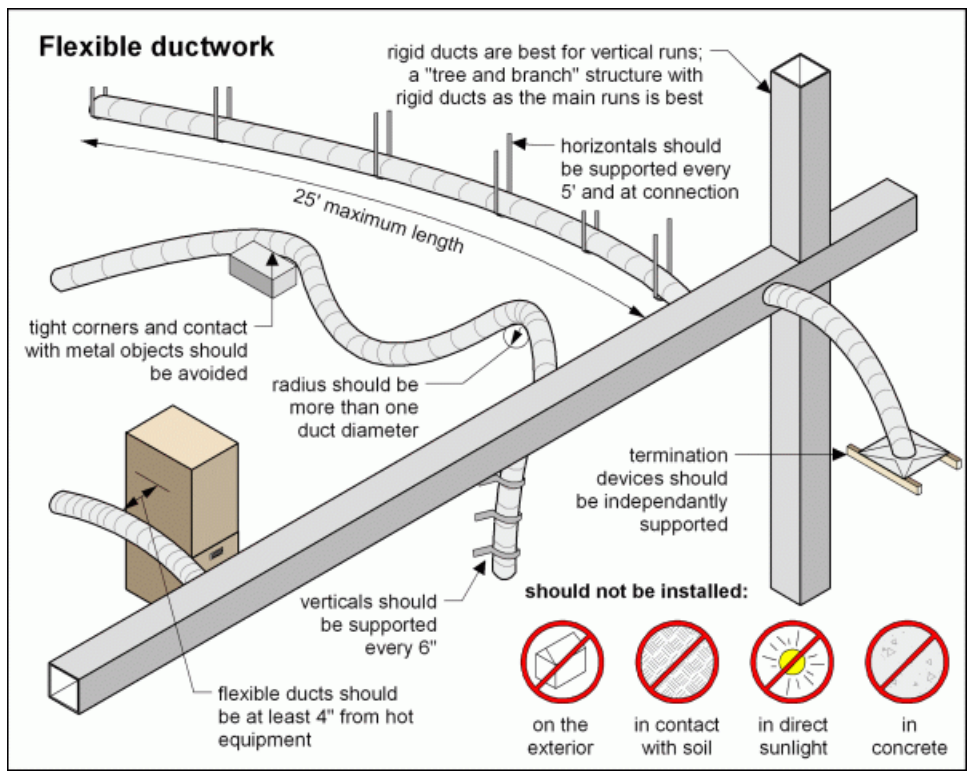
**11. Condition:** • [Weak airflow](#)

**Time:** If renovating

**Cost:** \$1000 and up

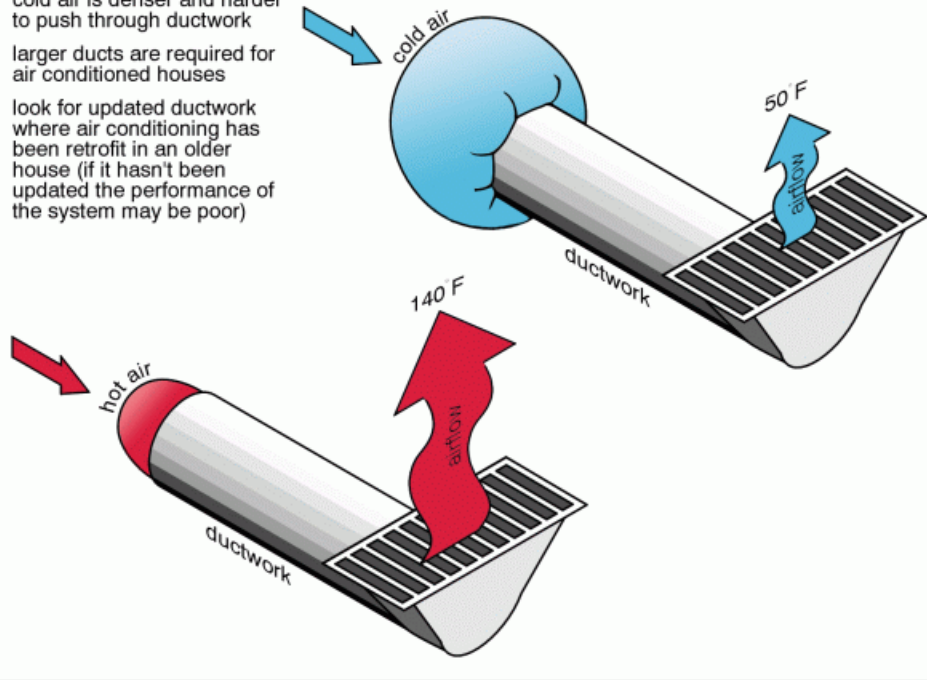
## Larger ducts are required for air conditioning

**12. Condition:** • [Weak airflow](#)

larger ducts are required for air conditioned houses

look for updated ductwork where air conditioning has been retrofit in an older house (if it hasn't been updated the performance of the system may be poor)

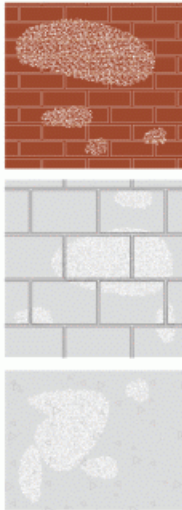
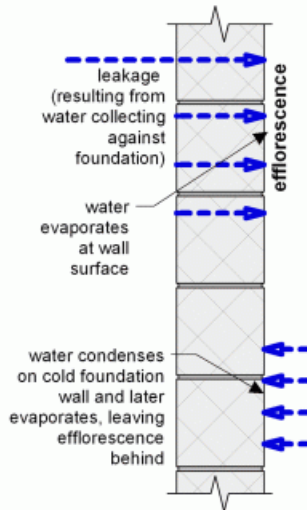
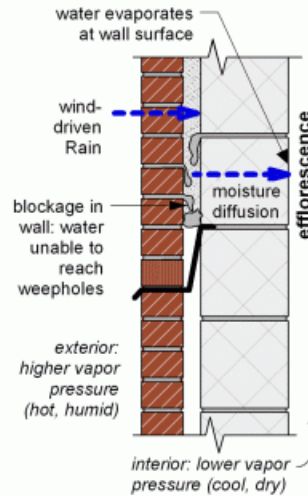
**Basement leakage clues - efflorescence**

### **18. Condition:** • [Efflorescence](#)

Typical efflorescence for this era and type of construction, no leakage noted. Introduce interior membrane of renovating basement.

**Implication(s):** Cosmetic defects | Chance of water damage to contents, finishes and/or structure

efflorescence is a powdery, white substance that appears when water with dissolved minerals evaporates

efflorescence may form because of water on the surface of the wall, either from leaks or from condensation, for example:

efflorescence may also form because of moisture diffusion through a wall

concrete and clay are not water-tight
