Your Inspection Report

27 Grafton Avenue
Toronto, ON M6R 1C3

Monday, September 11, 2017

RE: Report No. 2292
27 Grafton Avenue
Toronto, ON
M6R 1C3

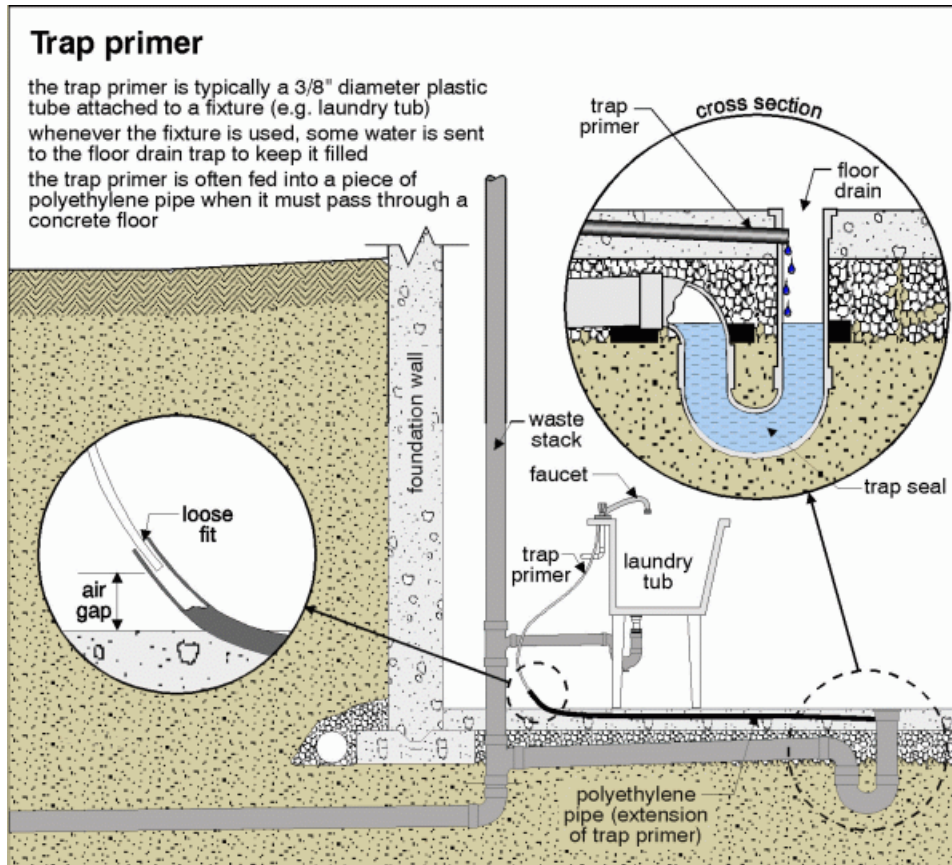
Location: South Basement

17. Condition: • [No primer or poor primer arrangement](#)

Implication(s): Sewer gases entering the building

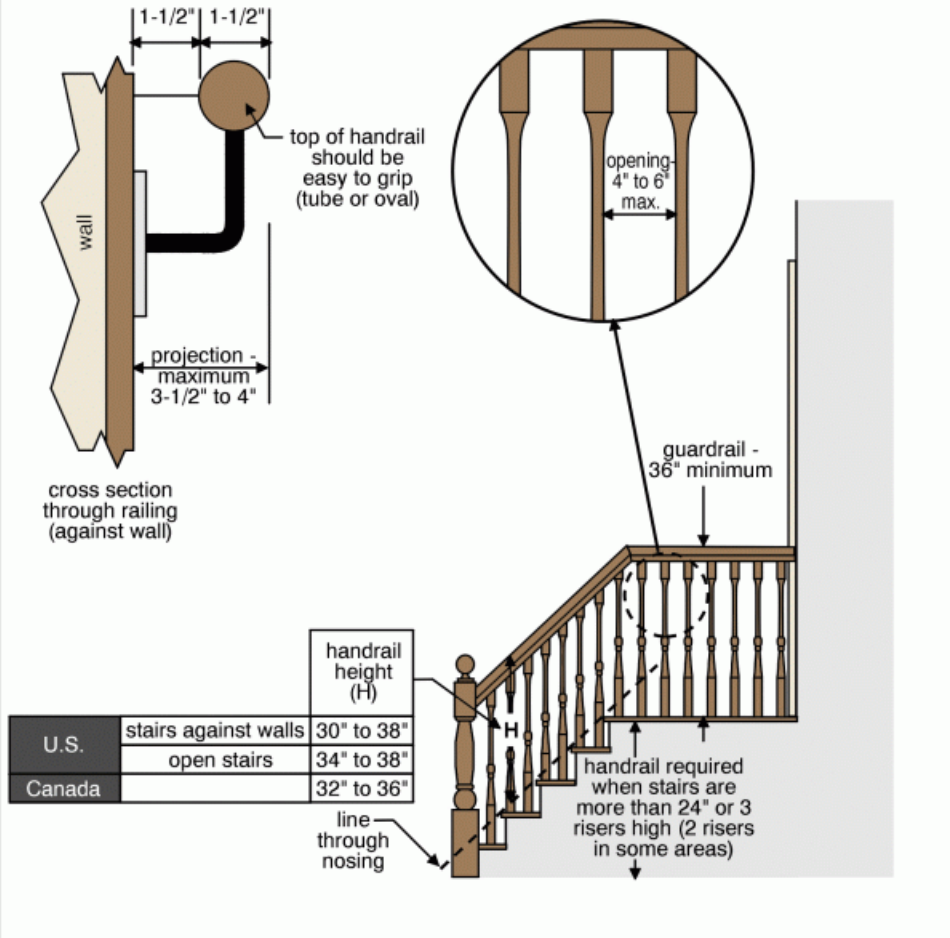
18. Condition: • [Missing](#)

Implication(s): Fall hazard

15. Missing guardrail
