Your Inspection Report

135 Cowan Avenue
Toronto, ON M6K 2N1

Friday, November 10, 2017

RE: Report No. 2354, v.3
135 Cowan Avenue
Toronto, ON
M6K 2N1

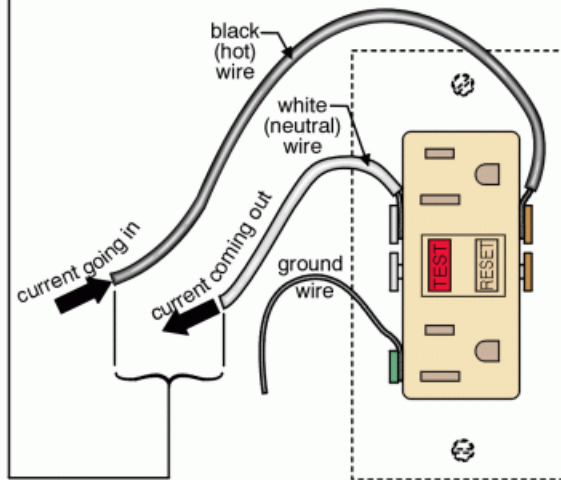
9. Condition: • [GFCI/GFI needed \(Ground Fault Circuit Interrupter\)](#)

Recommend gfci receptacles at all wet locations, including kitchen.

Task: Replace
