Your Inspection Report

217 Northcliffe Boulevard
Toronto, ON M6E 3K8

Monday, February 5, 2018

RE: Report No. 2403
217 Northcliffe Boulevard
Toronto, ON
M6E 3K8

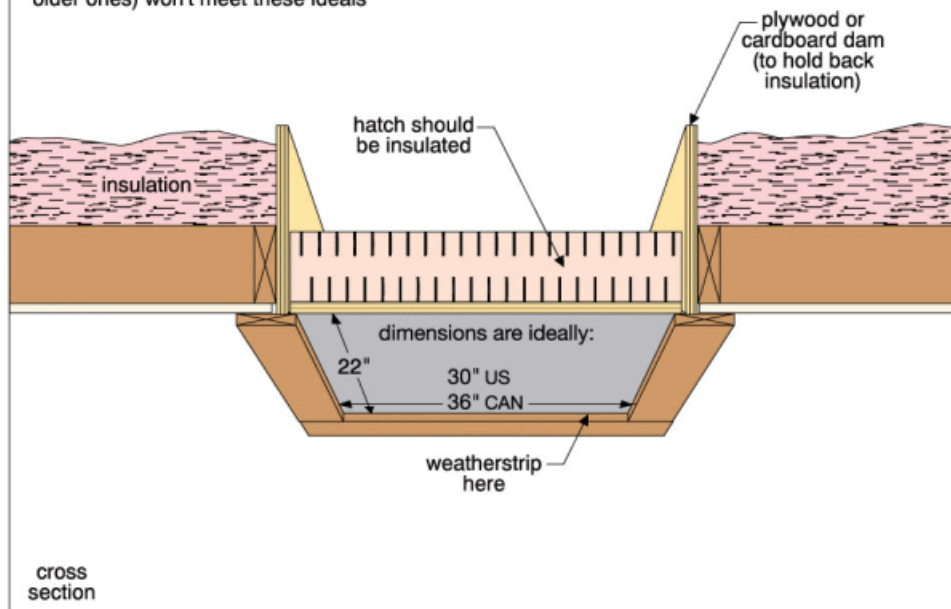
the illustration shows a good attic access hatch design

hatches in many houses (especially older ones) won't meet these ideals
