# Your Inspection Report

133 Macdonell Avenue  
Toronto, ON M6R 2A4

RE: Report No. 2464  
133 Macdonell Avenue  
Toronto, ON  
M6R 2A4

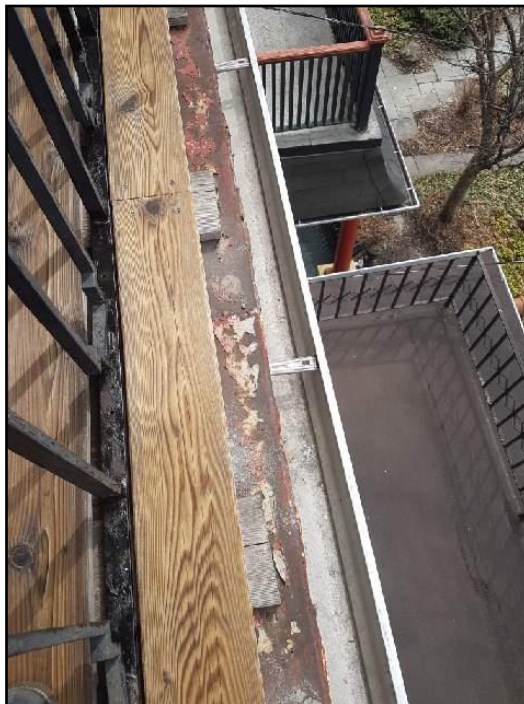
3. Metal

Probability of leakage: • High

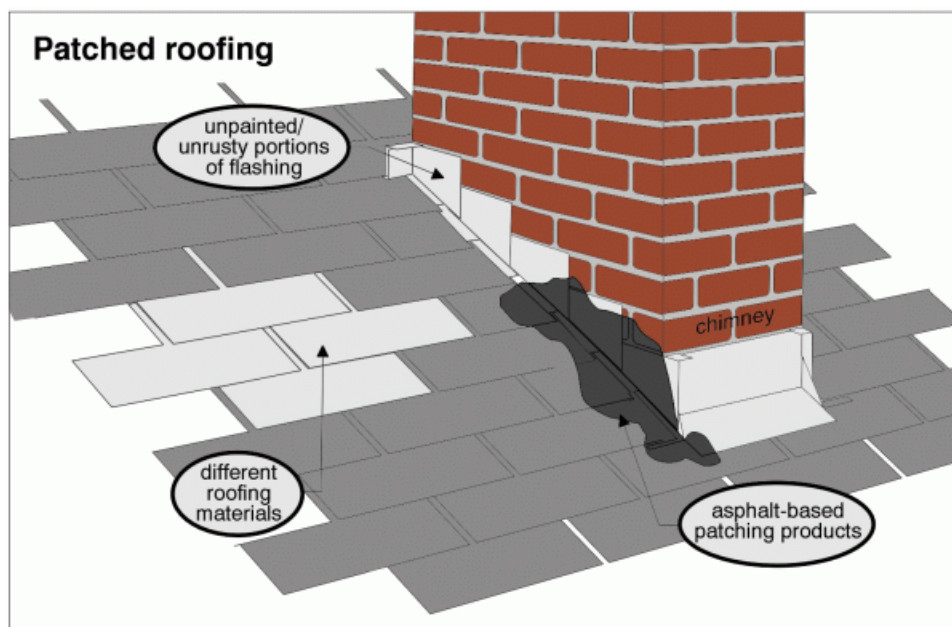
### 2. Condition: • [Patched](#)

Original slate will require annual inspection and periodic repair/maintenance. Previously patched areas in poor condition and need repair.

**Implication(s):** Chance of water damage to contents, finishes and/or structure

**Task:** Repair or replace

**Time:** Regular maintenance
