Your Inspection Report

725 Manning Avenue
Toronto, ON M6G 2W5

Tuesday, March 24, 2026

RE: Report No. 4437
725 Manning Avenue
Toronto, ON
M6G 2W5

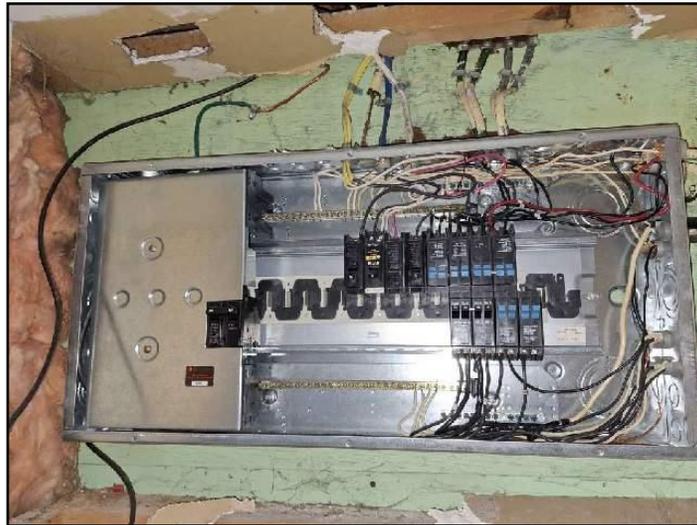
16.

- Service entrance cable and location: • [Overhead copper](#)
- Service size: • [100 Amps \(240 Volts\)](#)
- Main disconnect/service box rating: • [100 Amps](#)
- Main disconnect/service box type and location: • [Breakers - basement](#)
- System grounding material and type: • [Copper - water pipe](#)
- Distribution panel type and location:
 - [Breakers - basement](#)
