Your Inspection Report

194 Roxton Rd
Toronto, ON M6J2Y5

INSPECTION DATE:
Thursday, September 20, 2018

RE: Report No. 5125
194 Roxton Rd
Toronto, ON
M6J2Y5

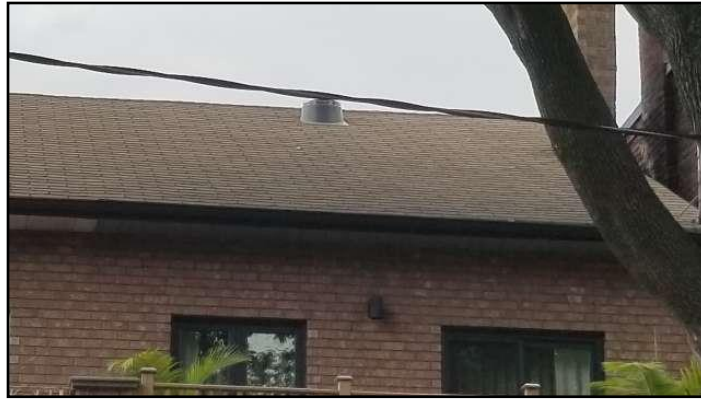
- [Asphalt shingles](#)

Probability of leakage: • Medium

Condition: • [Old, worn out](#)

Implication(s): Chance of water damage to contents, finishes and/or structure

Task: Replace

Time: Less than 2 years

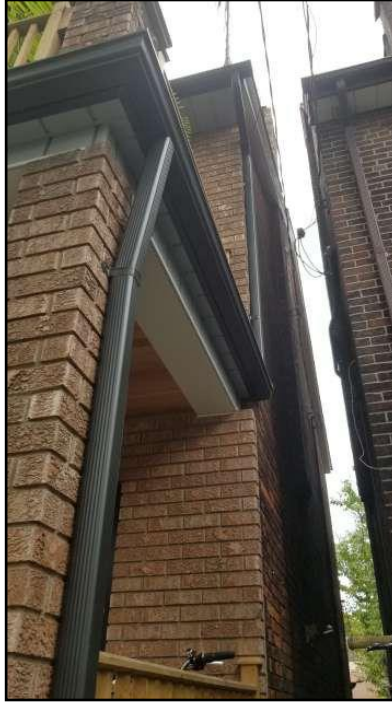
- [Aluminum](#)

Gutter & downspout type: • [Eave mounted](#)

Gutter & downspout discharge: • [Above grade](#)

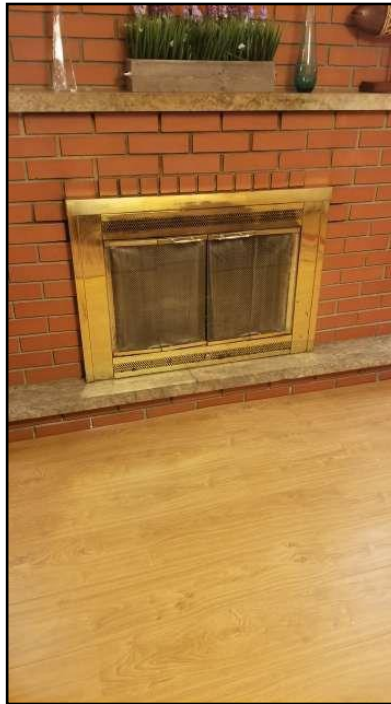
• [Wood-burning fireplace](#)

WETT certify before use

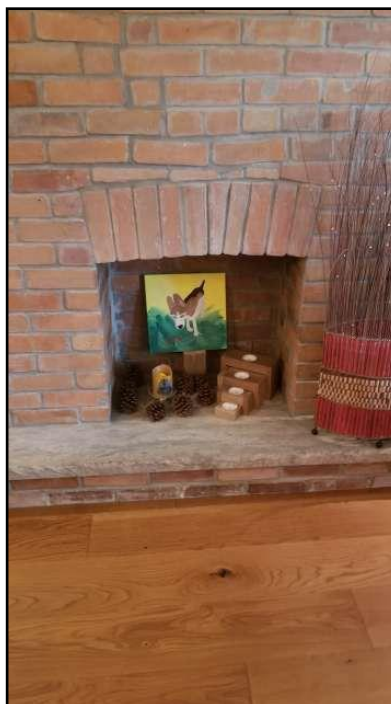
• Wood-burning fireplace - not in service
